TEE BEARING ON WALL BY OTHERS

STANDARD DETAIL NUMBER:
5.3.1.1.71.01

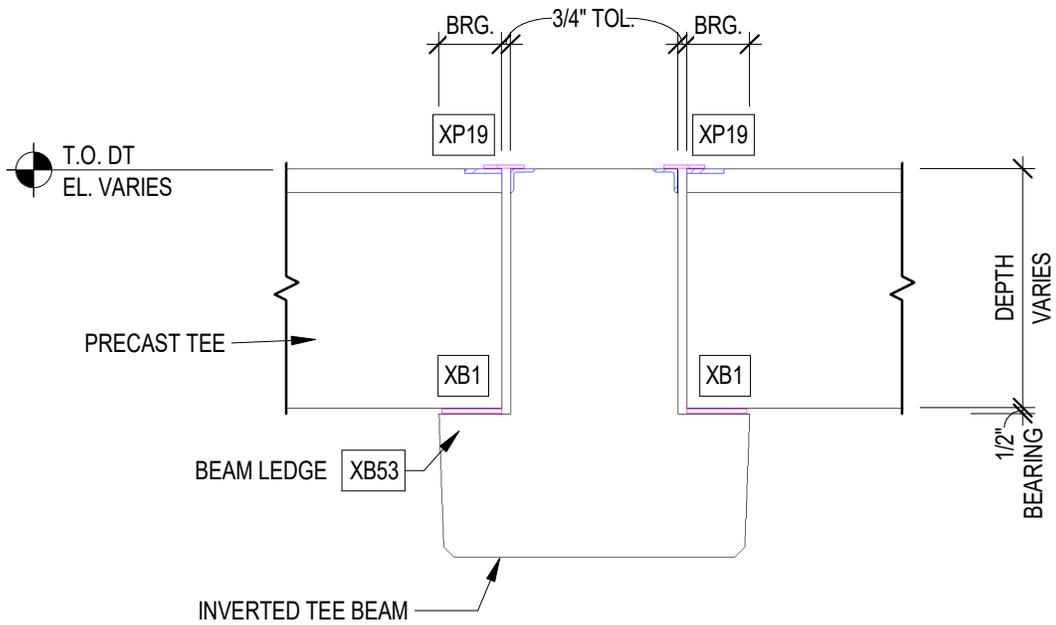
STANDARD DETAIL NUMBER:
5.3.1.1.73.01

TEE BEARING ON INVERTED TEE BEAM

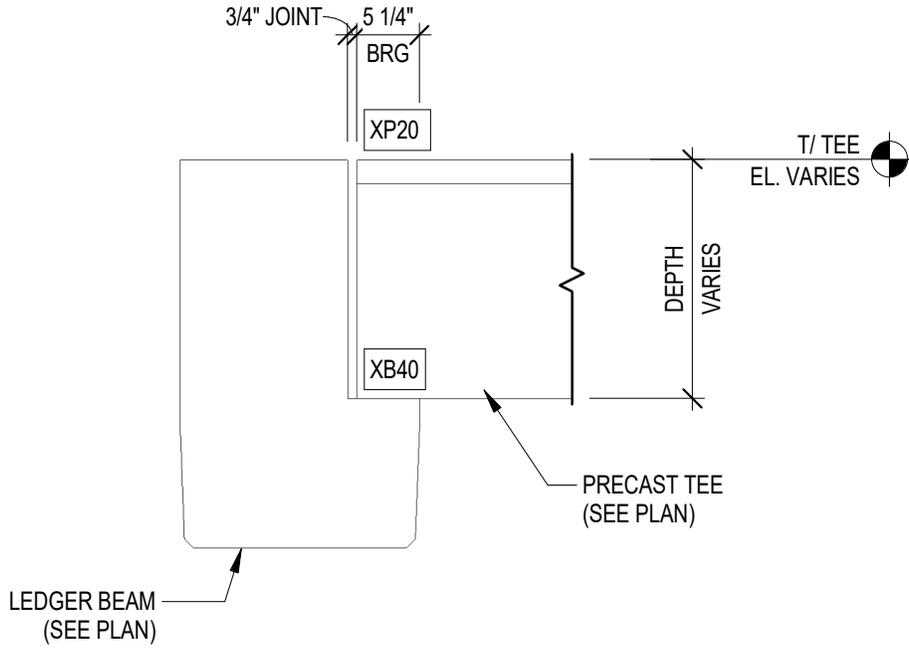
STANDARD DETAIL NUMBER:
5.3.1.1.73.02

TEE BEARING ON LEDGER BEAM

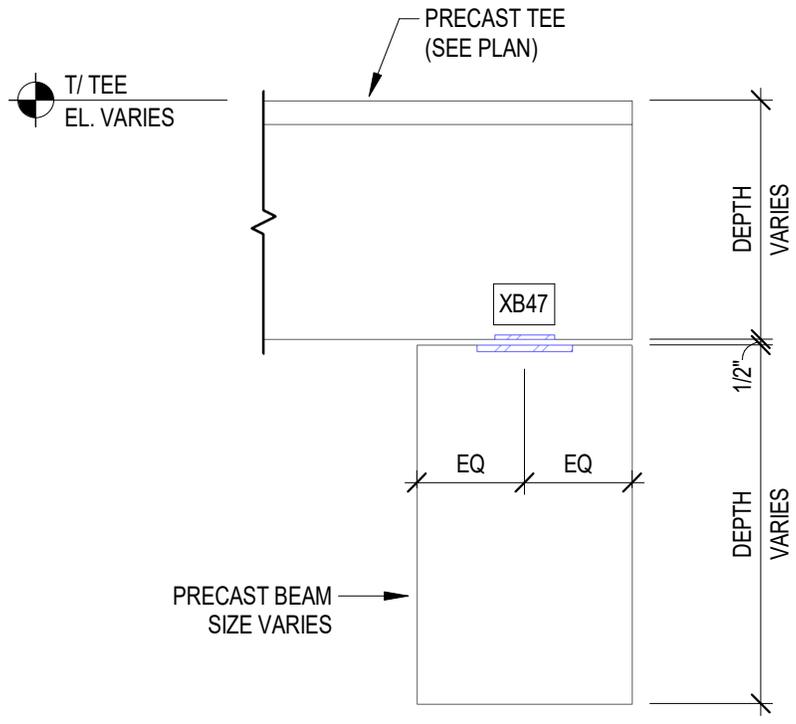
STANDARD DETAIL NUMBER:
5.3.1.1.73.03

DETAIL NAME: **TEE BEARING ON RECTANGULAR BEAM**

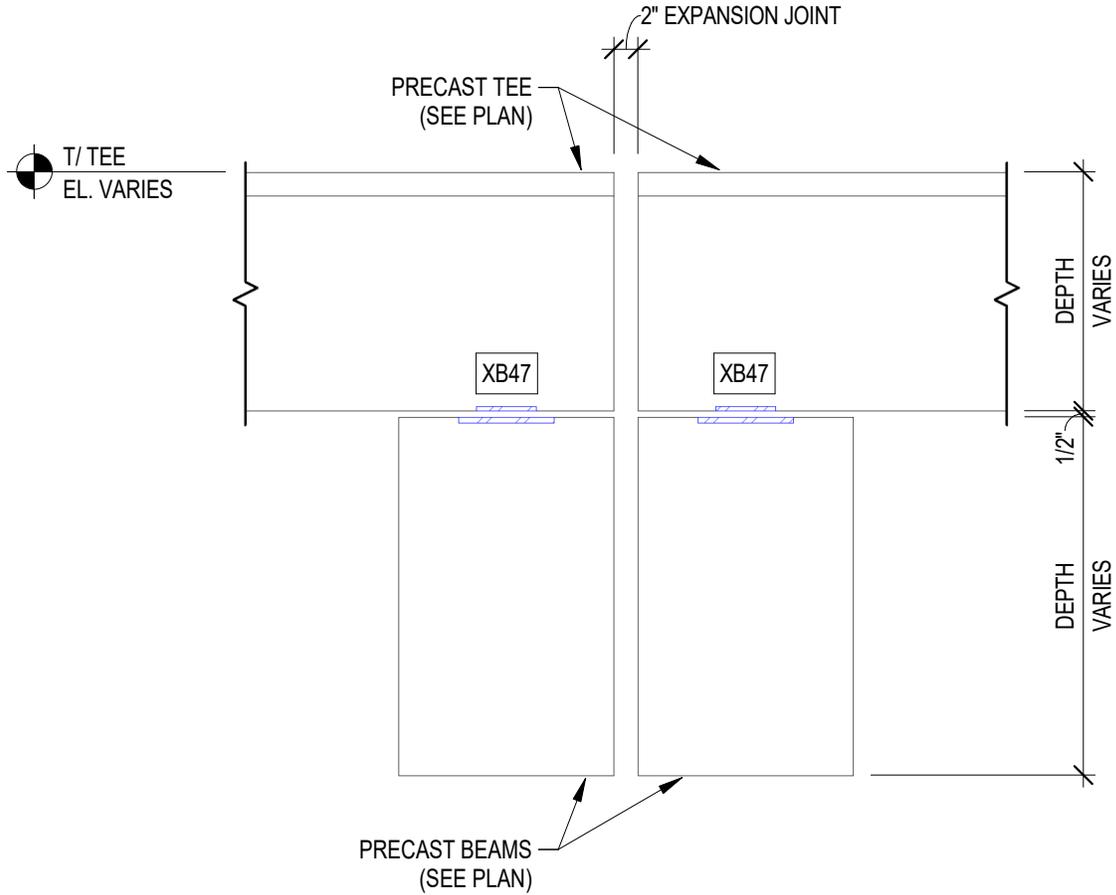
STANDARD DETAIL NUMBER:
5.3.1.1.73.98

TEES AT EXPANSION JOINT BEARING ON DOUBLE BEAM AND COLUMN LINES

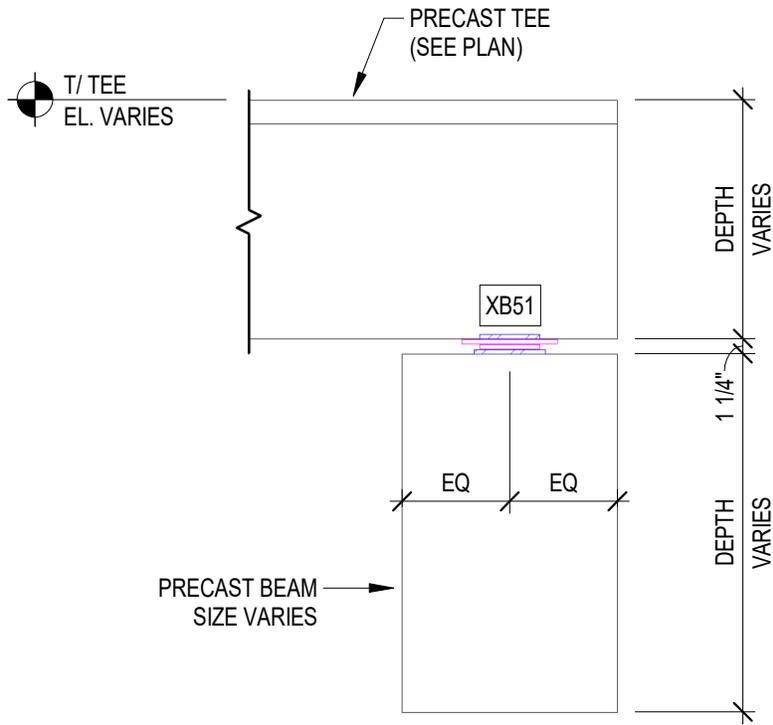
STANDARD DETAIL NUMBER:
5.3.1.1.73.99

TEE BEARING ON RECTANGULAR BEAM WITH SLIP CONNECTION

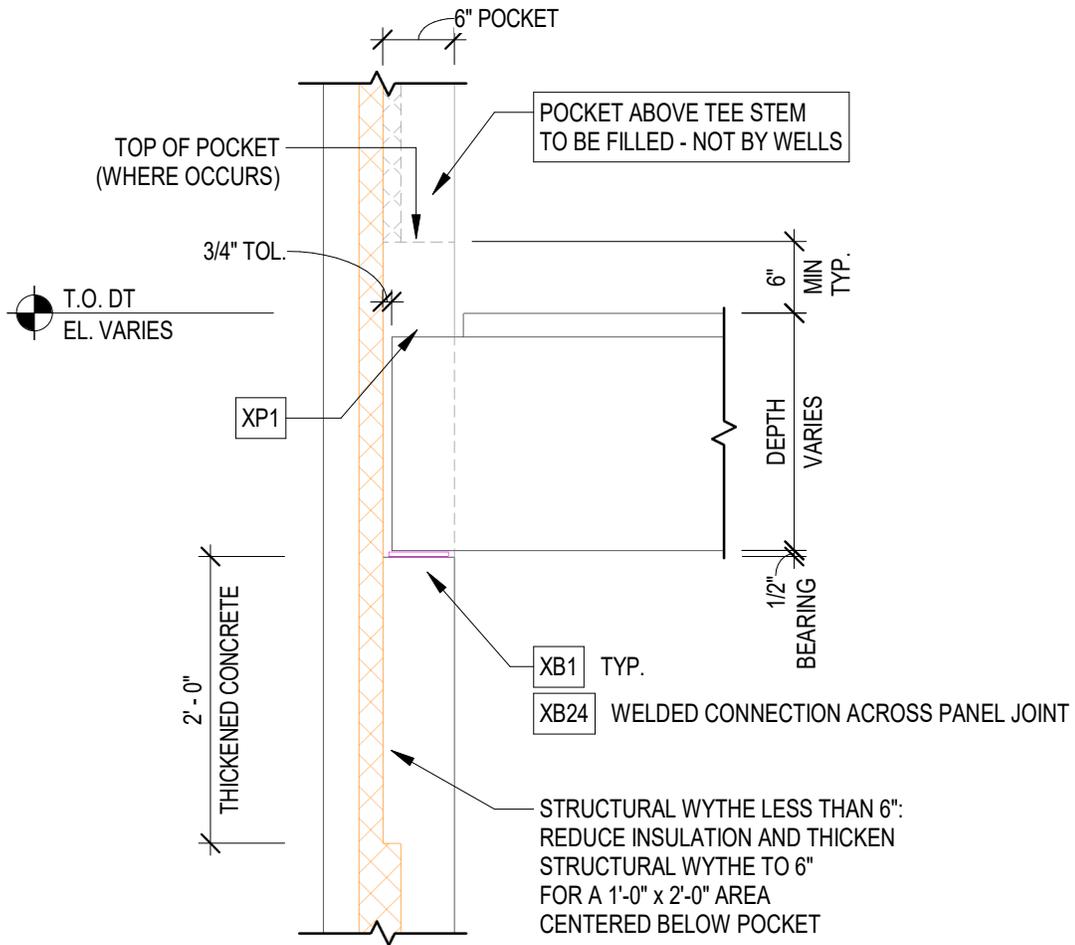
5.3.1.1.74.01

TEE BEARING IN POCKET OF WALL PANEL SOLID WALL OR STRUCTURAL WYTHE

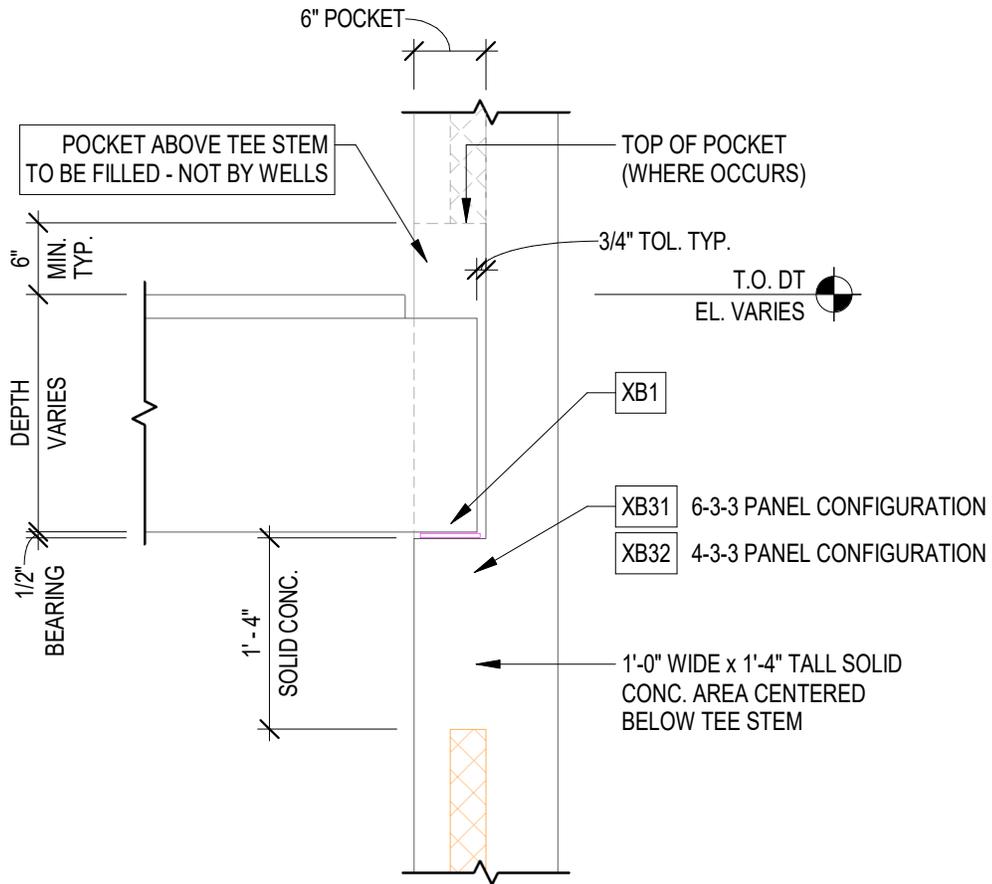
STANDARD DETAIL NUMBER:
5.3.1.1.74.02

TEE BEARING IN POCKET OF WALL PANEL INSULATED PANEL AT THIN WYTHE

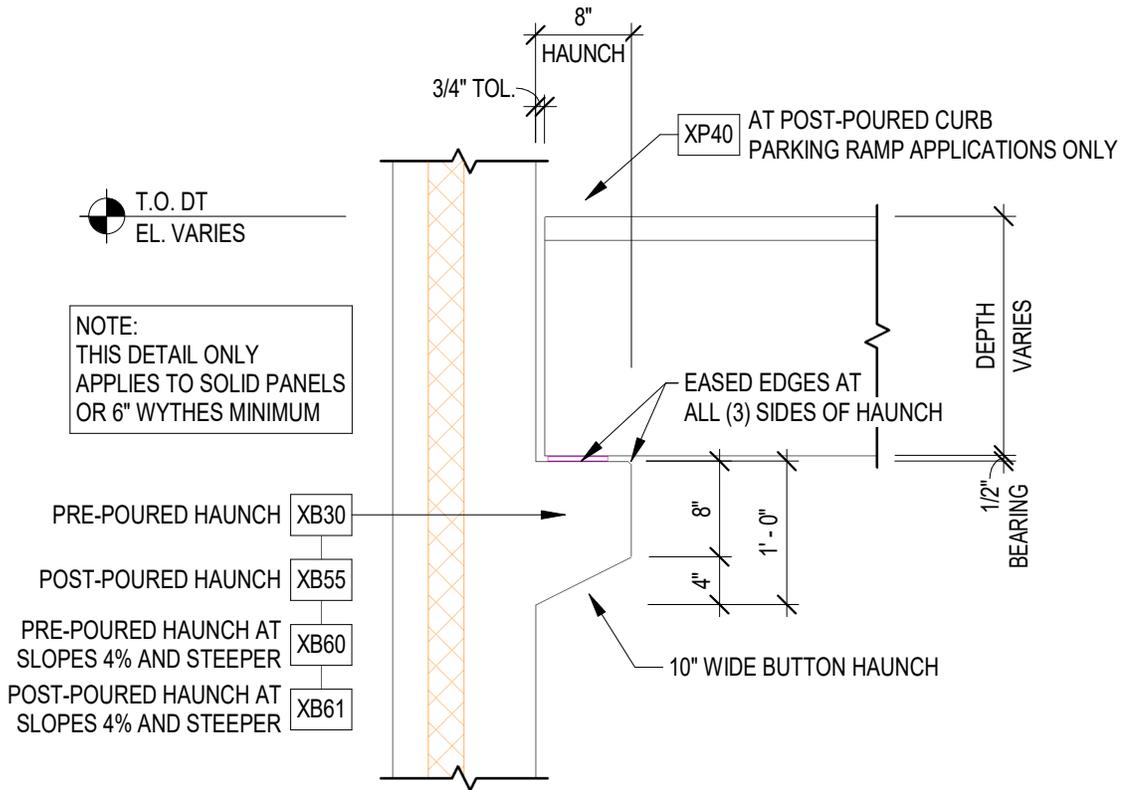
STANDARD DETAIL NUMBER:
5.3.1.1.74.03

TEE BEARING ON BUTTON HAUNCH SOLID WALL OR 6" STRUCTURAL WYTHE
